Inspection Report

Example Report

Property Address:
123 Any Street Ave.
Orlando FL 32000

i-Inspect, LLC

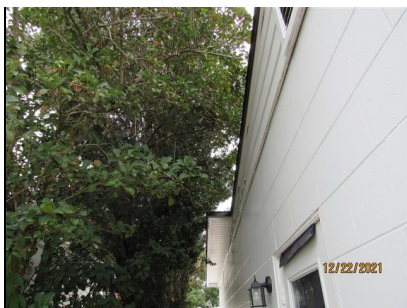
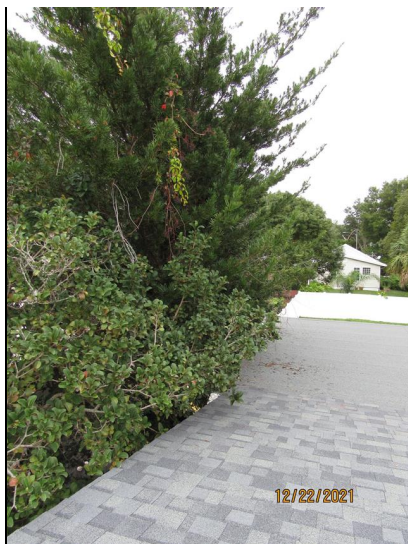
The tree limbs that are in contact with roof or hanging near roof should be trimmed. It is recommended that tree limbs be kept 6 to 8 feet away from the home.

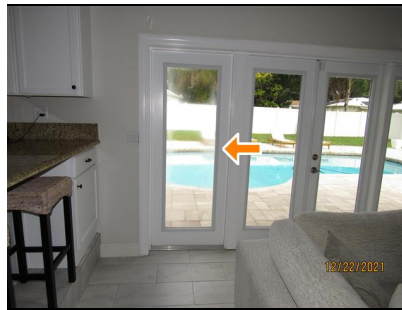
3.1 Item 1(Picture)

(1) One of the glass doors is cloudy (lost seal) at the den. In order to correct the cloudy appearance of glass, a replacement of glass pane or the unit will be necessary. A qualified contractor should inspect and repair as needed.

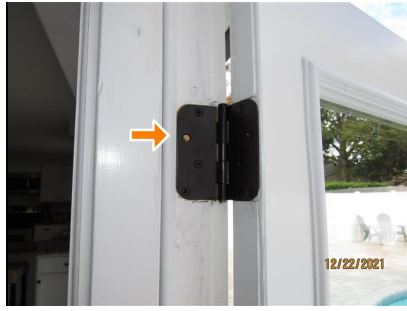
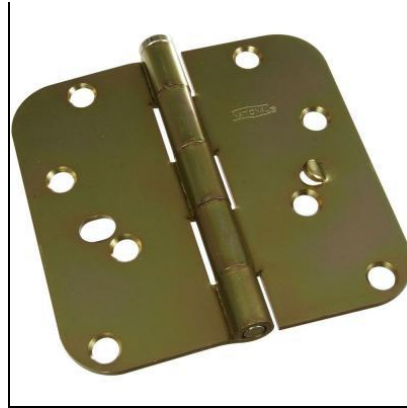
3.1 Item 3(Picture) Missing screw

3.1 Item 4(Picture) typical security hinge

(3) The doors at rear of home are missing steel security screw at each hinge. This is a security issue. A qualified person should repair or replace as needed.

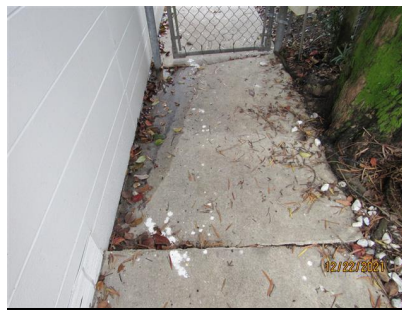
3.3 Item 1(Picture)

One piece of sidewalk has been lifted by the adjacent tree roots, causing a negative slope towards the home. A licensed contractor should correct as necessary.

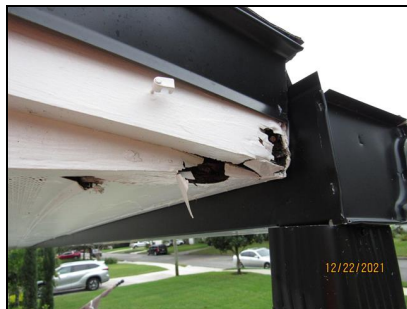
3.4 Item 2(Picture) Bottom of lap siding - left side

The fascia board at eave on the left side (facing front) is deteriorated. Repairs are needed. A qualified contractor should inspect and repair as needed.

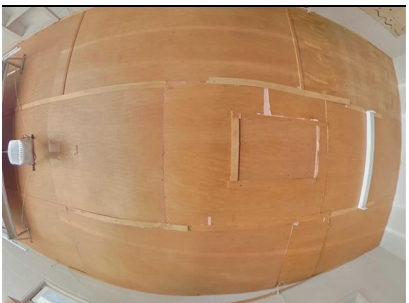
4.0 Item 1(Picture)

The Wood panels on the ceiling at the garage do not meet the fire separation requirements from the home. One-Half inch drywall is the minimum. Repairs are needed. Full replacement is likely. A qualified contractor should inspect and repair as needed.

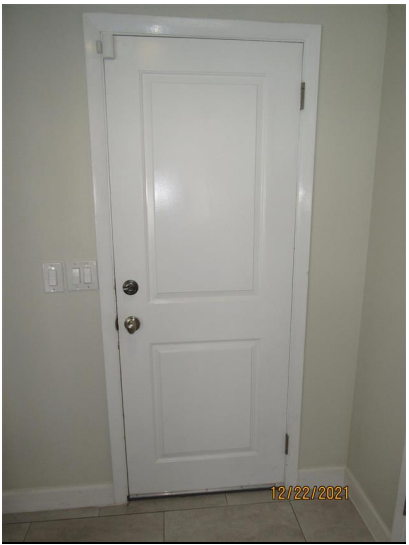
4.4 Item 1(Picture)

The occupant door from inside garage to inside the home is not appropriate. Door should be 20 minute fire rated or 1-3/8 inch solid wood or steel. This means that should a fire occur in garage, the occupant door does not afford protection until fireman arrive. This door should be replaced with an appropriate door.

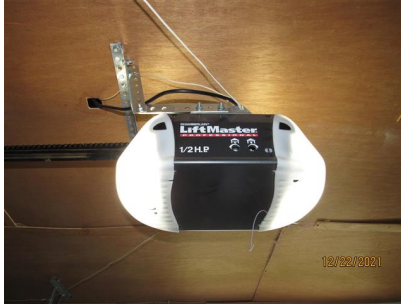
4.5 Item 1(Picture)

The garage door will reverse when met with 10 pounds of resistance in the downward direction BUT will NOT stop when met with 10 pounds of resistance in the upward direction. The sensors are in place and will reverse the door.

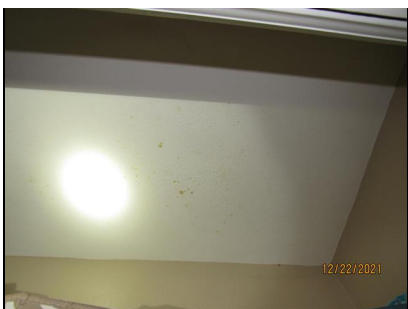
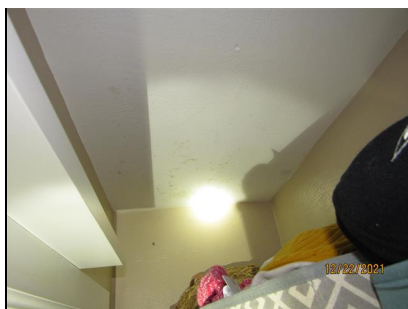
Signs of fungi growth are present on ceiling in several areas in the front corner bedroom closet. We did not inspect, test or determine if this growth is or is not a health hazard. The underlying cause is moisture or dampness. I recommend you contact a mold inspector or expert for investigation or correction if needed.

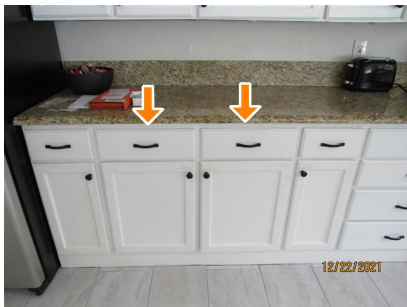
5.3 Item 1(Picture)

Two Drawers are stuck and will not open (right of refrigerator). Recommend repair or replace as necessary.

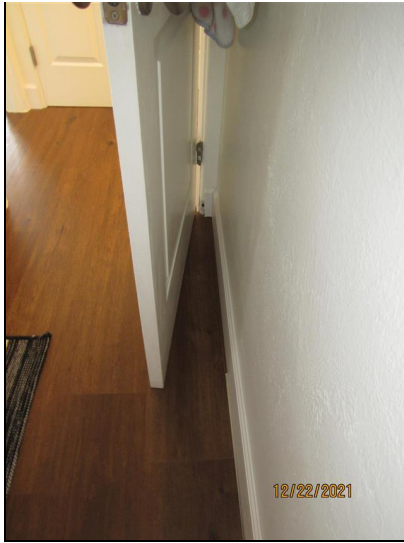
5.4 Item 1(Picture) Master Bedroom

(1) Doorstops are needed throughout the home.

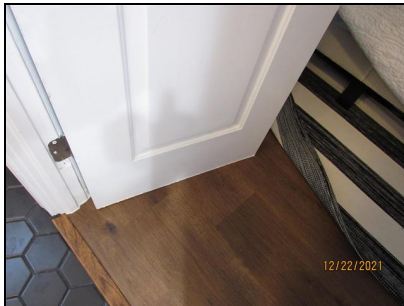
5.4 Item 4(Picture) Master Bath

(2) The Entry door rubs floor when opened. Door needs to be trimmed at bottom by a skilled craftsman at the Master bath. This is a small repair. A qualified person should repair or replace as needed.

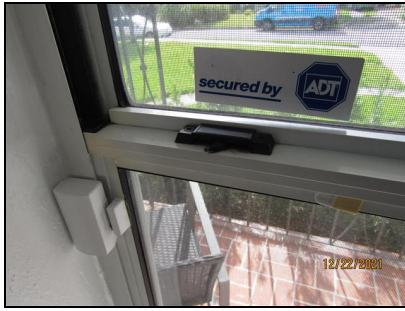
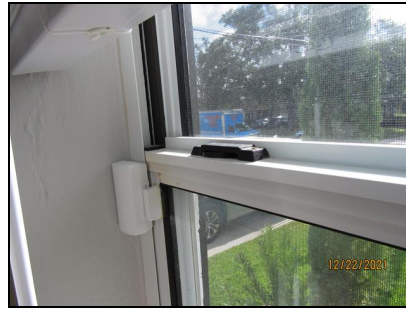
(1) Windows are damaged at lock hardware. This is a safety issue. A qualified person should repair or replace as needed.

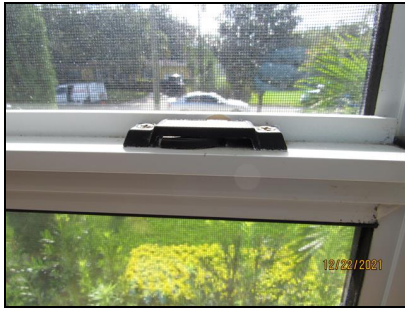
5.5 Item 3(Picture) Front Corner Bedroom

(2) Windows are damaged at the spring mechanism and will not stay up without a prop. This is a small repair. A qualified person should repair or replace as needed.

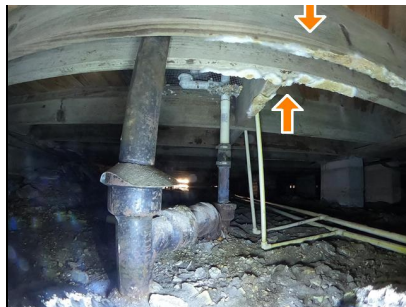
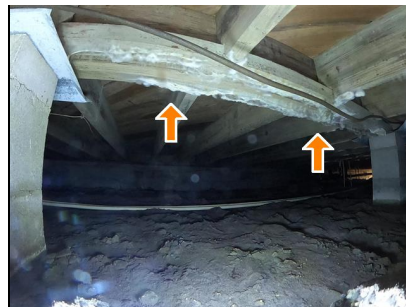
Signs of fungi growth is present on the floor system in crawlspace in several areas. We did not inspect, test or determine if this growth is or is not a health hazard. The underlying cause is moisture. I recommend you contact a mold inspector or expert for investigation or correction if needed.

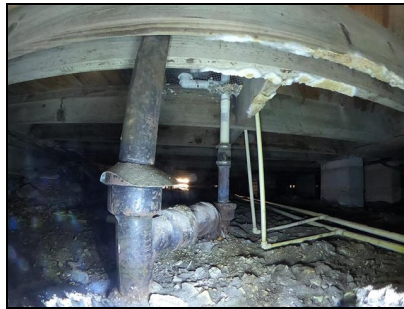
7.0 Item 1(Picture)

Your home has cast iron sewer lines. Cast iron corrodes from the inside. A visual inspection of the exterior cannot determine the condition or remaining life of the system. A sewer scope is recommended to aid you in determining the condition of your system.

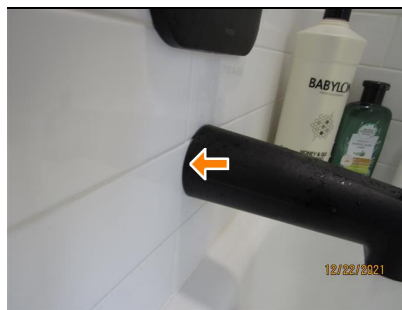
7.1 Item 1(Picture)

The tub spout is loose in wall at the hall bath. This may allow water to enter behind the tile wall and damage the backing and wood framing. I recommend caulk as necessary by a qualified person.

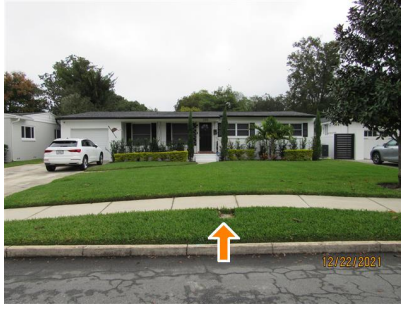
7.3 Item 1(Picture)

The main shut off is located outside in the ground at the meter.

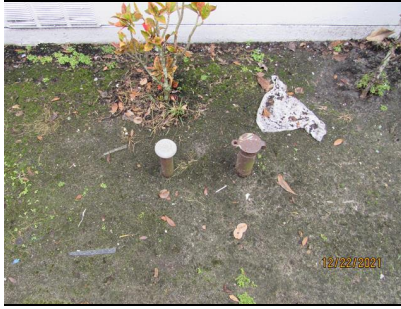
7.4 Item 1(Picture)

The oil barrel is located underground at the right side of home. This can contaminate the soil and should be corrected. I did not inspect the soil. A qualified contractor should inspect and remove the old oil barrel. If the oil barrel has leaked, remediation may be required.

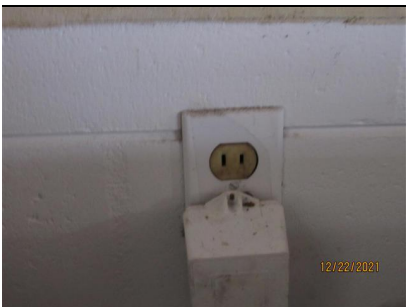
8.2 Item 1(Picture)

(1) Many outlets in the home are older two-prong outlets. This is from an older system prior to modern three-prong grounded outlets. These outlets are typical from the time the home was built, but do not offer the protection of a modern system. Ungrounded 2-prong electrical outlets do not provide an effective pathway for equipment grounding procedures. The recommendation is to consult a licensed electrical contractor for your options.

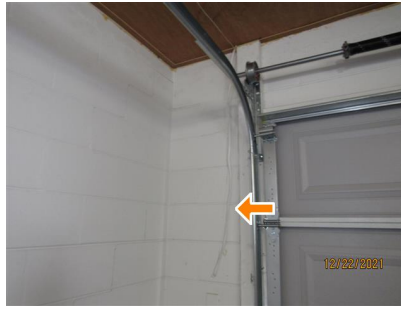
8.2 Item 2(Picture)

(2) NM cable is permitted to be run exposed on the surface of the building finish unless subject to physical damage. Then it requires supplemental protection. A licensed electrical contractor should correct as necessary.

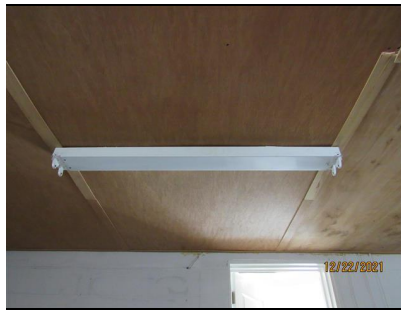
8.3 Item 1(Picture) Garage

(1) Some light fixtures do not work (try bulb first) throughout the home. If changing the bulb does not correct the problem, then further inspection is needed by a licensed electrician.. I recommend repair as needed.

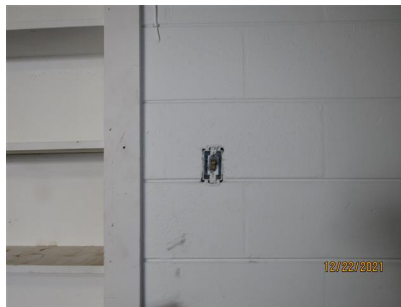
8.3 Item 2(Picture)

(2) One switch is missing the cover-plate in the bedroom. This is a safety issue that needs to be corrected. I recommend repair as needed.

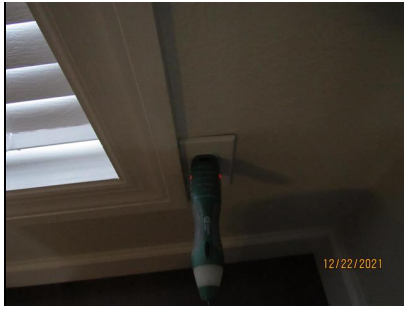
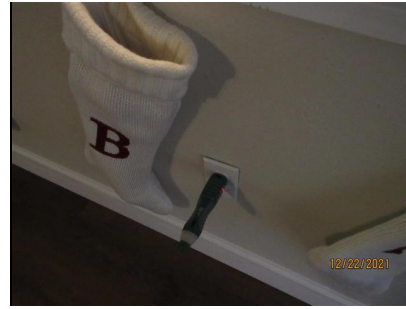
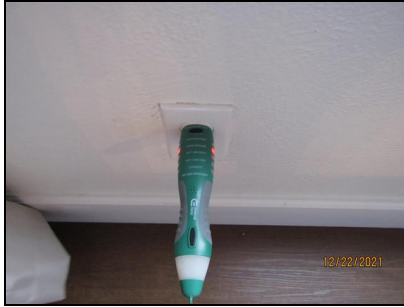
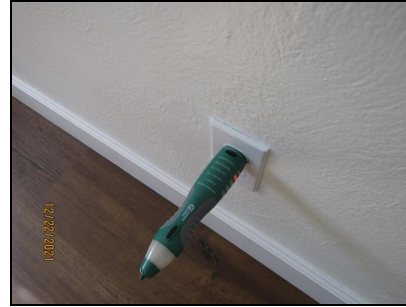
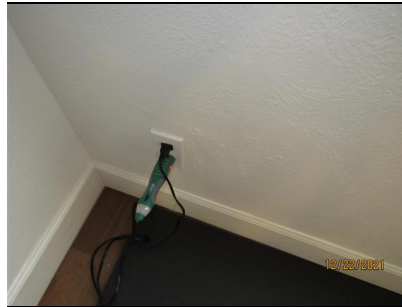
(1) This home was not built with a grounded system, but has had the outlets changed from two-prong to three-prong outlets. Three-prong outlets imply that the system is grounded.

- (a) Replace it with another 2-wire receptacle;
- (b) Replace it with a GFCI-type receptacle and mark the receptacle with the words "No Equipment Ground" or
- (c) Replace it with a grounding-type receptacle protected by a GFCI device (circuit breaker or receptacle). Since the grounding terminals for the receptacles are not grounded, you must mark the receptacles with the words "GFCI Protected" and "No Equipment Ground"
- (d) Rewire the home to provide grounds.

A licensed electrical contractor should further investigate and repair as necessary.

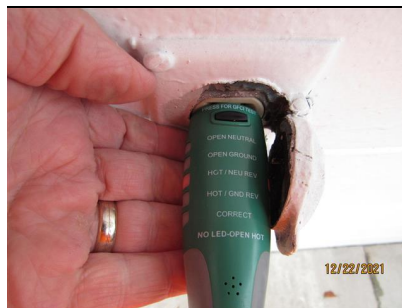
8.4 Item 6(Picture) Rear of home

(2) The exterior outlet at the rear of home showing "reversed polarity," and may not be grounded or a loose ground connection. Electrical issues are considered a hazard until repaired. A qualified licensed electrical contractor should perform repairs that involve wiring.

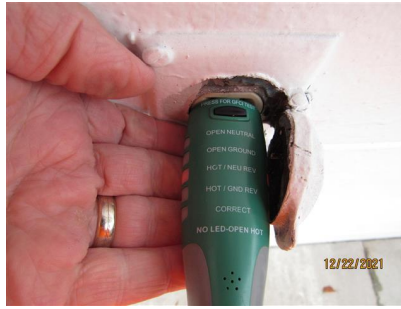
8.5 Item 1(Picture) Rear of home

(1) All outlets at the exterior should be protected by a GFCI and have a weatherproof cover. This is a safety issue that needs to be corrected. A qualified licensed electrical contractor should correct as needed.

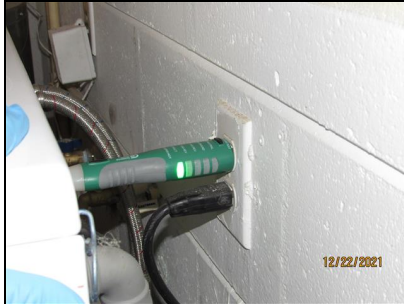
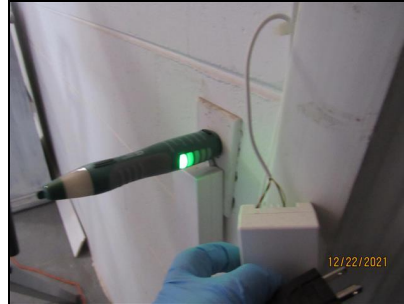
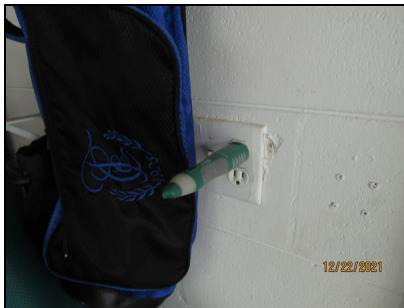
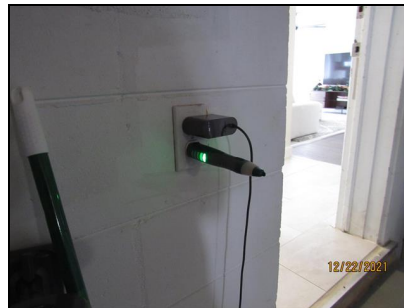
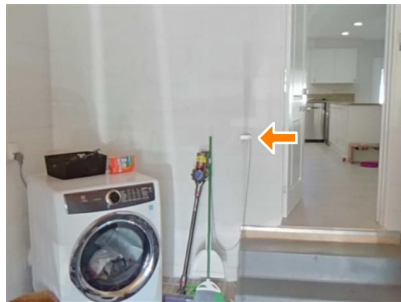
(2) All outlets at the Garage should be protected by a GFCI. This is a safety issue that needs to be corrected. A qualified licensed electrical contractor should correct as needed.

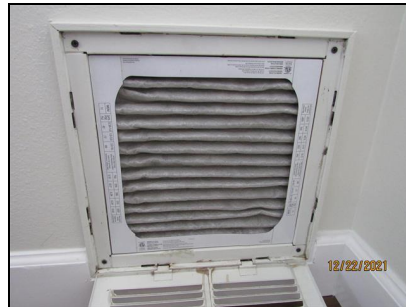
9.4 Item 2(Picture)

Most systems are designed to function optimally with a MERV 8 Filter. Filters that are too open (less than MERV 8) may allow dust and particles through and end up with a dirty evaporator coil. Filters too tight (greater than MERV 8) may reduce the air flow through the system and cause the unit to run longer.

Filters should be replaced every 30 days.

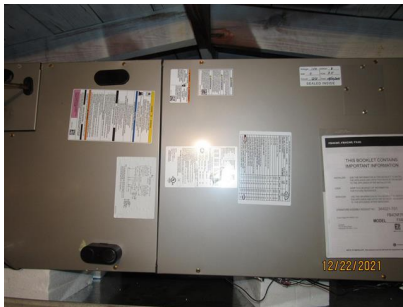
9.5 Item 1(Picture)

The ambient air test was performed by using thermometers on the air handler of Heat pump in cool mode to determine if the difference in temperatures of the supply and return air are between 14 degrees and 22 degrees which indicates that the unit is cooling as intended. The supply air temperature on your system read 51 degrees, and the return air temperature was 72 degrees. This indicates the range in temperature change is normal.

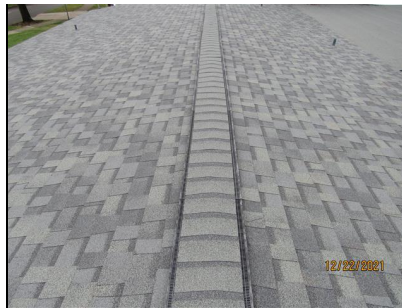
10.3 Item 1(Picture)

Ridge vent does not function well with a ridge beam under it. Box vents (off-ridge vents) would be a better choice.

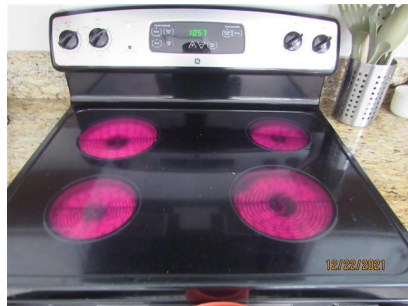
11.3 Item 1(Picture)

The stove is missing an anti-tip device to prevent the stove from tipping forward. This is a safety issue. I recommend that a qualified person install an anti-tip device for this stove.

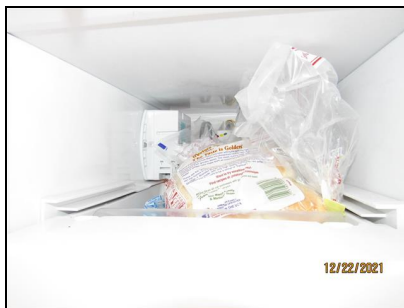
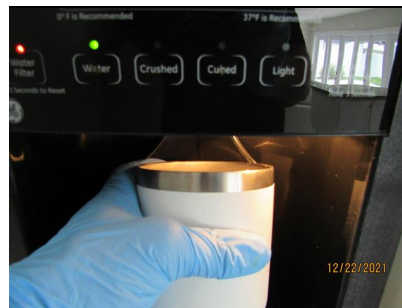
The refrigerator does not have an automatic ice maker. This is for your information.

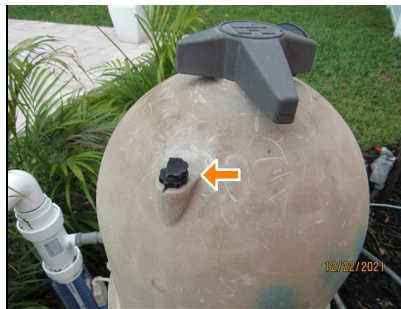
12.3 Item 1(Picture)

(1) The air bleed for the filter is damaged. A replacement should be installed by a qualified person.

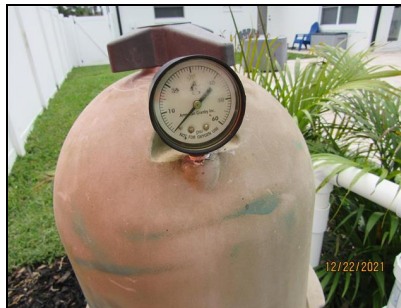
12.3 Item 2(Picture)

(2) The pressure gauge is damaged and should be replaced by a qualified person.

The pressure gauge is damaged and should be replaced by a qualified person.

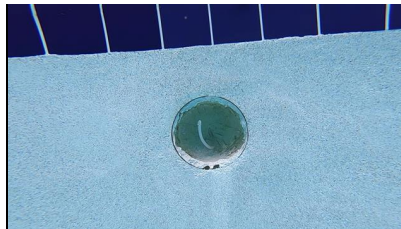
12.5 Item 1(Picture)

Pool light has been removed. The wall niche is still present. A licensed pool technician or electrician should correct as necessary.

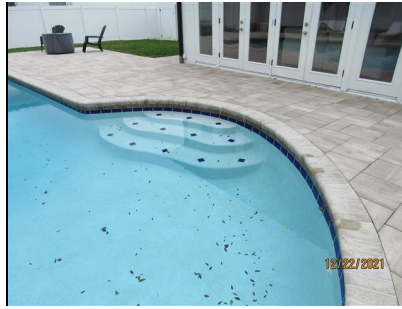
12.8 Item 1(Picture)

There is only one set of steps out of the pool. Current safety standards call for two means of exit (such as a deck mounted pool ladder or other).

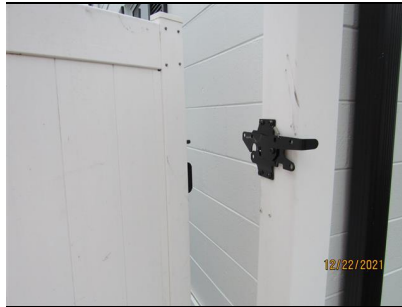
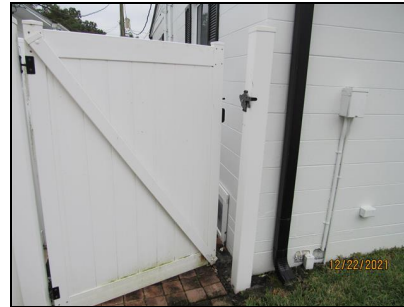
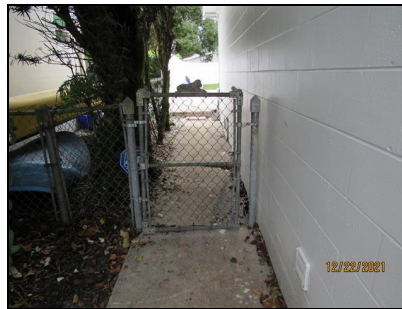
12.11 Item 1(Picture) Right gate not self latching

Gate is not self-closing / self-latching. Gates should open outward (away from the pool) and have the latch mechanism at a minimum height of 54 inches from the bottom of the gate.

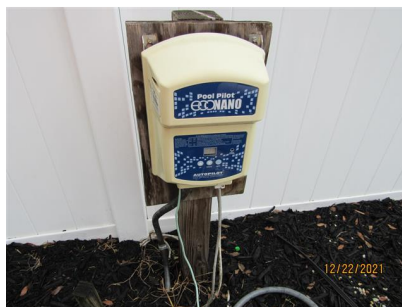
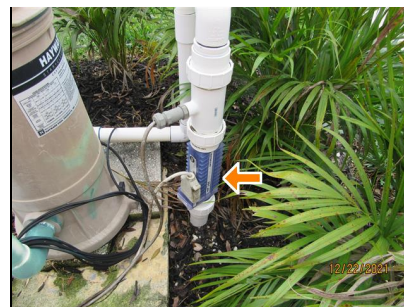
12.15 Item 1(Picture)

Chlorinating system uses salt.

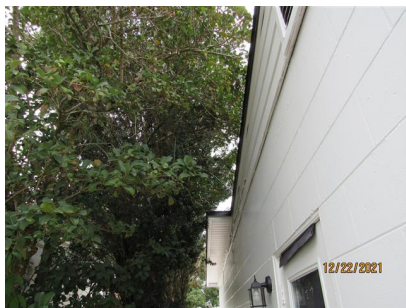
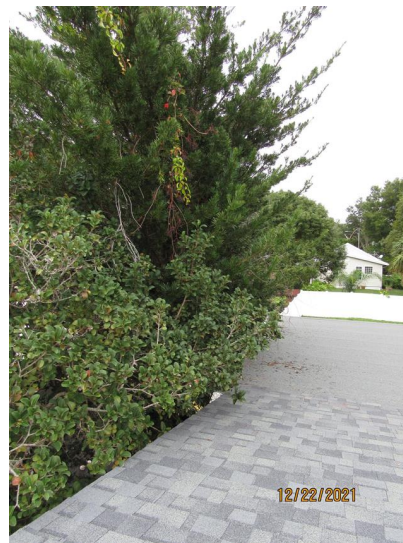
2.0 Item 1(Picture)

The tree limbs that are in contact with roof or hanging near roof should be trimmed. It is recommended that tree limbs be kept 6 to 8 feet away from the home.

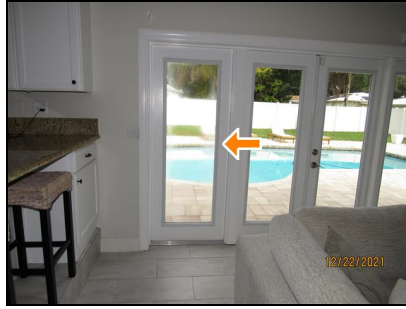
3.1 Item 1(Picture)

One of the glass doors is cloudy (lost seal) at the den. In order to correct the cloudy appearance of glass, a replacement of glass pane or the unit will be necessary. A qualified contractor should inspect and repair as needed.
(2)

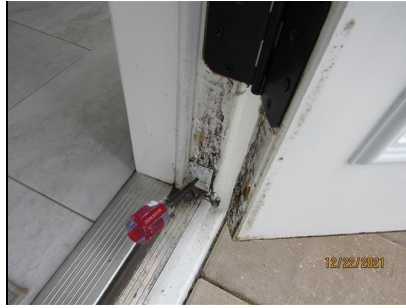
3.1 Item 2(Picture)

The rear entry doors are deteriorated at bottom of jamb (s) and at the core of the door from moisture. A repair or replacement is needed. A qualified contractor should inspect and repair as needed.
(3)

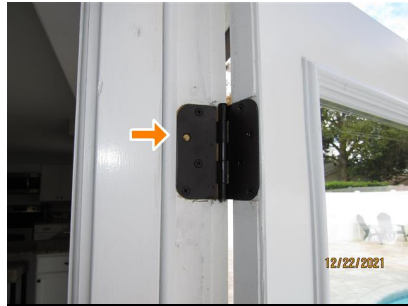
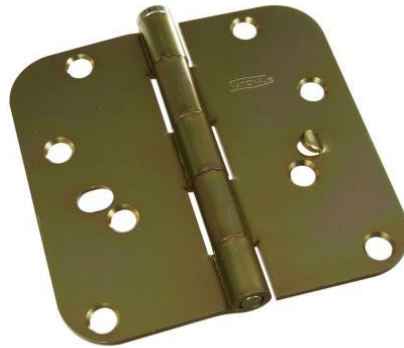
3.1 Item 3(Picture) Missing screw

The doors at rear of home are missing steel security screw at each hinge. This is a security issue. A qualified person should repair or replace as needed.

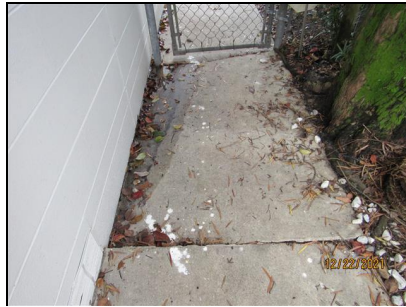
3.3 Item 1(Picture)

One piece of sidewalk has been lifted by the adjacent tree roots, causing a negative slope towards the home. A licensed contractor should correct as necessary.

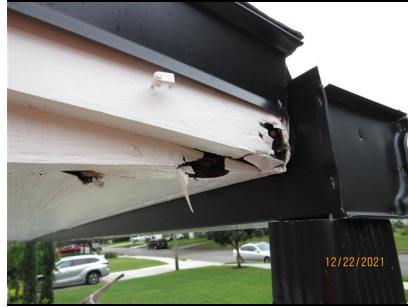
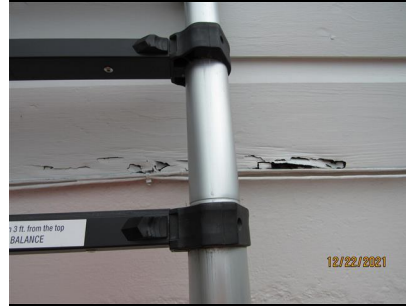
3.4 Item 1(Picture)

The fascia board at eave on the left side (facing front) is deteriorated. Repairs are needed. A qualified contractor should inspect and repair as needed.

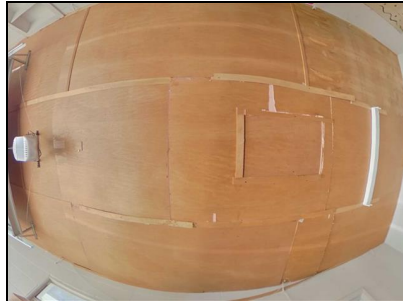
4.0 Item 1(Picture)

The Wood panels on the ceiling at the garage do not meet the fire separation requirements from the home. One-Half inch drywall is the minimum. Repairs are needed. Full replacement is likely. A qualified contractor should inspect and repair as needed.

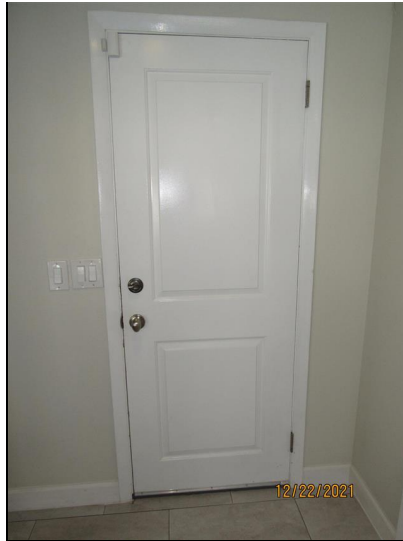
4.4 Item 1(Picture)

The occupant door from inside garage to inside the home is not appropriate. Door should be 20 minute fire rated or 1-3/8 inch solid wood or steel. This means that should a fire occur in garage, the occupant door does not afford protection until fireman arrive. This door should be replaced with an appropriate door.

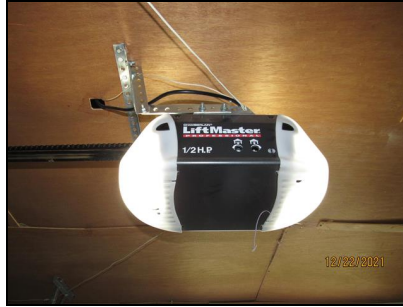
4.5 Item 1(Picture)

The garage door will reverse when met with 10 pounds of resistance in the downward direction BUT will NOT stop when met with 10 pounds of resistance in the upward direction. The sensors are in place and will reverse the door.

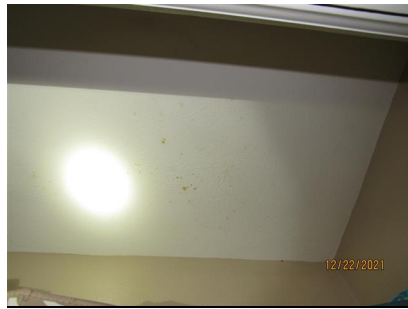
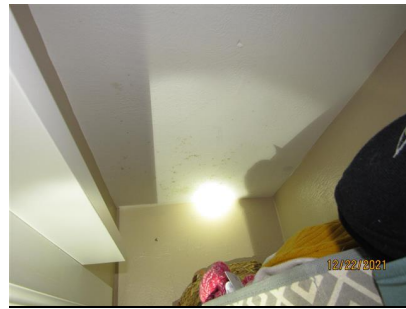
5.0 Item 1(Picture)

Signs of fungi growth are present on ceiling in several areas in the front corner bedroom closet. We did not inspect, test or determine if this growth is or is not a health hazard. The underlying cause is moisture or dampness. I recommend you contact a mold inspector or expert for investigation or correction if needed.

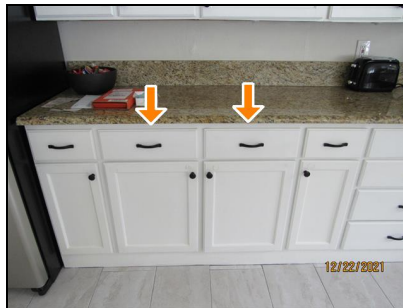
5.3 Item 1(Picture)

Two Drawers are stuck and will not open (right of refrigerator). Recommend repair or replace as necessary.

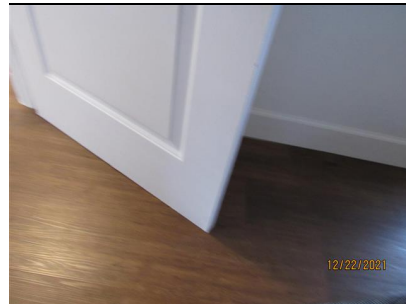
5.4 Item 5(Picture) Master Bedroom

The Entry door rubs floor when opened. Door needs to be trimmed at bottom by a skilled craftsman at the Master bath. This is a small repair. A qualified person should repair or replace as needed.

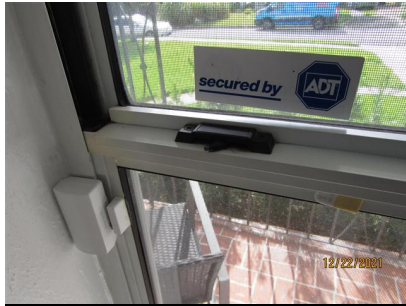
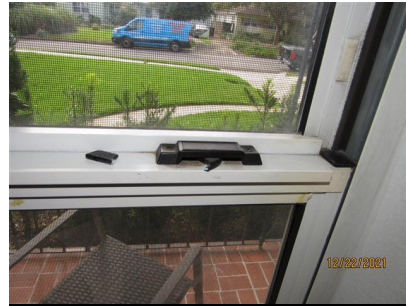
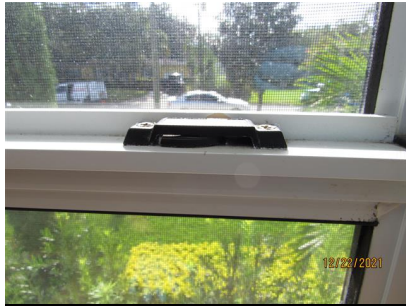
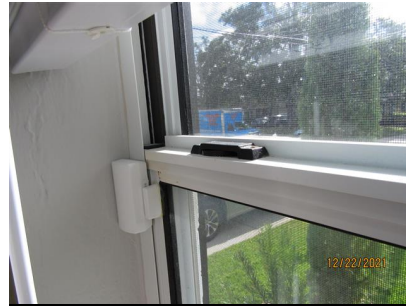
5.5 Item 1(Picture) Living Room

Windows are damaged at lock hardware. This is a safety issue. A qualified person should repair or replace as needed.

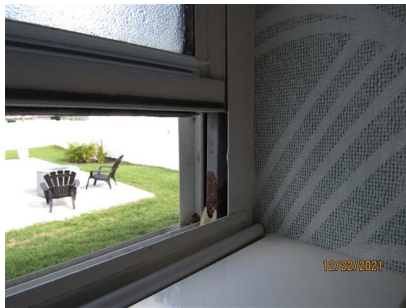
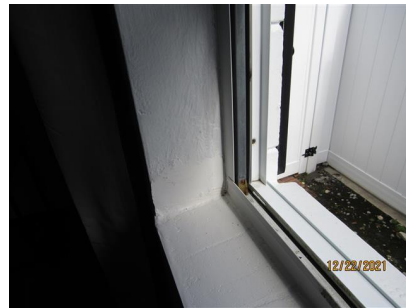
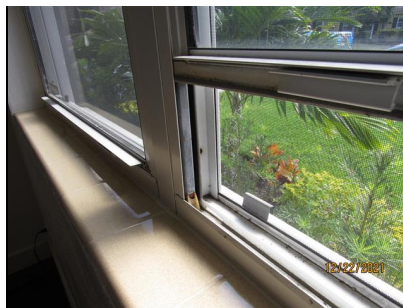
5.5 Item 5(Picture) Master Bath

Windows are damaged at the spring mechanism and will not stay up without a prop. This is a small repair. A qualified person should repair or replace as needed.

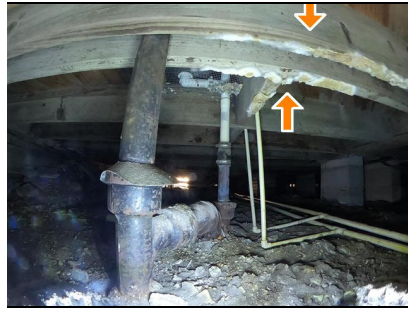
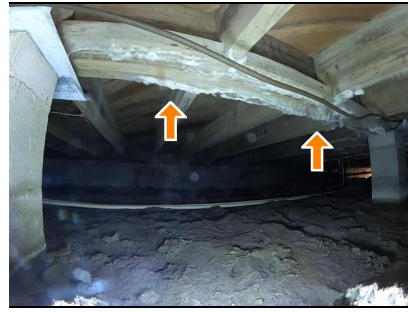
6.0 Item 1(Picture)

Signs of fungi growth is present on the floor system in crawlspace in several areas. We did not inspect, test or determine if this growth is or is not a health hazard. The underlying cause is moisture. I recommend you contact a mold inspector or expert for investigation or correction if needed.

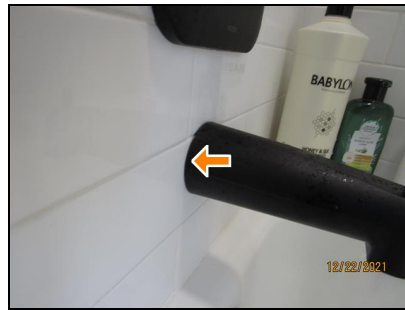
7.1 Item 1(Picture)

The tub spout is loose in wall at the hall bath. This may allow water to enter behind the tile wall and damage the backing and wood framing. I recommend caulk as necessary by a qualified person.

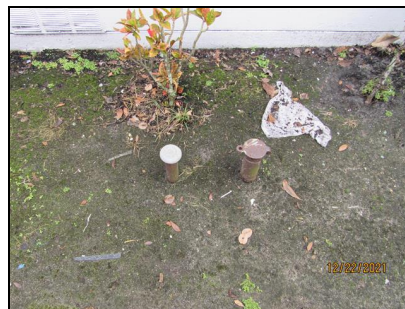
7.4 Item 1(Picture)

The oil barrel is located underground at the right side of home. This can contaminate the soil and should be corrected. I did not inspect the soil. A qualified contractor should inspect and remove the old oil barrel. If the oil barrel has leaked, remediation may be required.

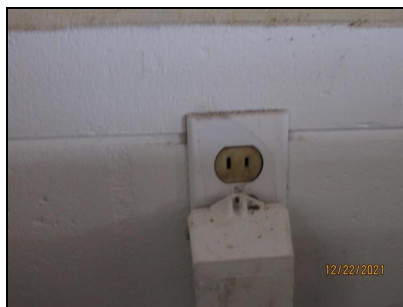
8.2 Item 1(Picture)

Many outlets in the home are older two-prong outlets. This is from an older system prior to modern three-prong grounded outlets. These outlets are typical from the time the home was built, but do not offer the protection of a modern system. Ungrounded 2-prong electrical outlets do not provide an effective pathway for equipment grounding procedures. The recommendation is to consult a licensed electrical contractor for your options.

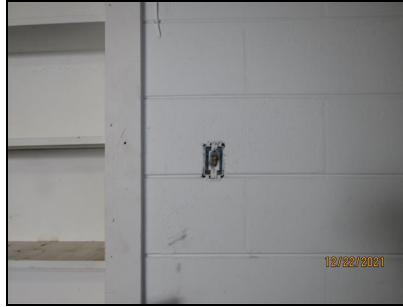
8.3 Item 2(Picture)

One switch is missing the cover-plate in the bedroom. This is a safety issue that needs to be corrected. I recommend repair as needed.

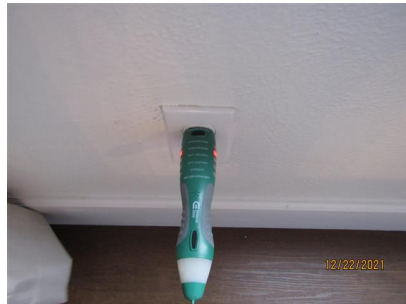
8.4 Item 3(Picture) Master Bedroom

This home was not built with a grounded system, but has had the outlets changed from two-prong to three-prong outlets. Three-prong outlets imply that the system is grounded.

- (a) Replace it with another 2-wire receptacle;
- (b) Replace it with a GFCI-type receptacle and mark the receptacle with the words "No Equipment Ground" and a diamond symbol; or
- (c) Replace it with a grounding-type receptacle protected by a GFCI device (circuit breaker or receptacle). Since the grounding terminals for the receptacles are not grounded, you must mark the receptacles with the words "GFCI Protected" and "No Equipment Ground";
- (d) Rewire the home to provide grounds.

A licensed electrical contractor should further investigate and repair as necessary.

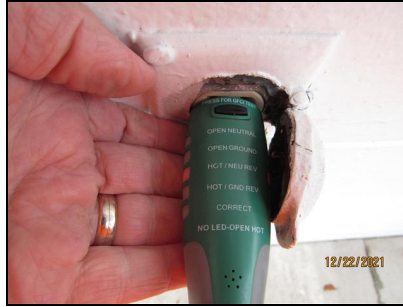
8.4 Item 6(Picture) Rear of home

The exterior outlet at the rear of home showing "reversed polarity," and may not be grounded or a loose ground connection. Electrical issues are considered a hazard until repaired. A qualified licensed electrical contractor should perform repairs that involve wiring.

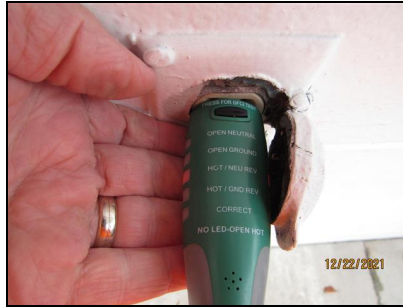
8.5 Item 1(Picture) Rear of home

All outlets at the exterior should be protected by a GFCI and have a weatherproof cover. This is a safety issue that needs to be corrected. A qualified licensed electrical contractor should correct as needed.

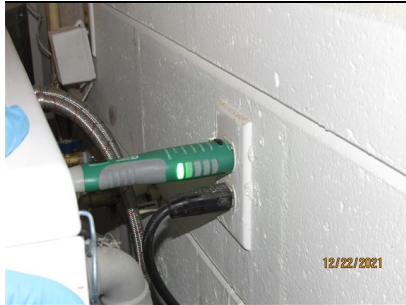
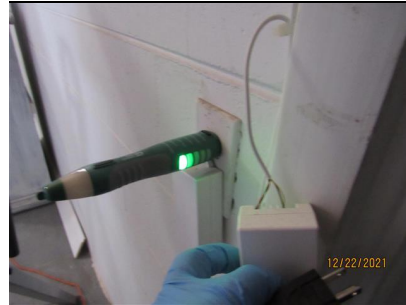
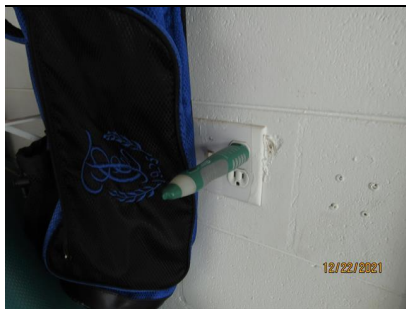
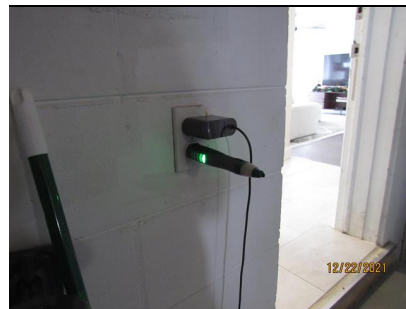
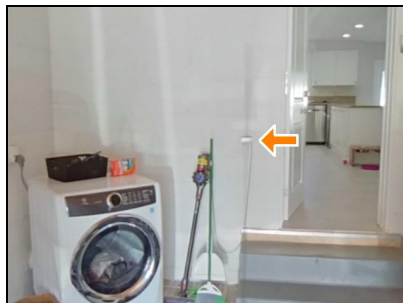
All outlets at the Garage should be protected by a GFCI. This is a safety issue that needs to be corrected. A qualified licensed electrical contractor should correct as needed. (3)

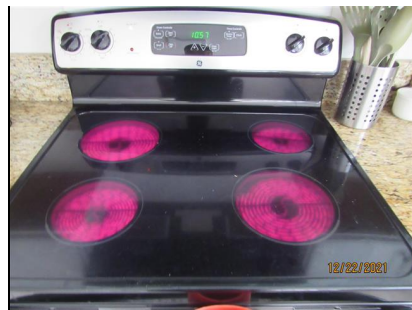
11.3 Item 1(Picture)

The stove is missing an anti-tip device to prevent the stove from tipping forward. This is a safety issue. I recommend that a qualified person install an anti-tip device for this stove.

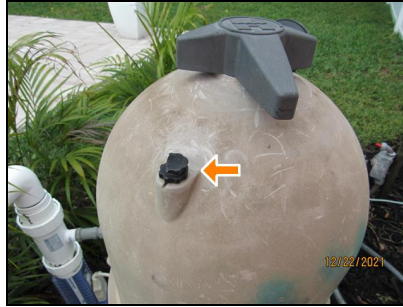
12.3 Item 1(Picture)

The air bleed for the filter is damaged. A replacement should be installed by a qualified person.
(2)

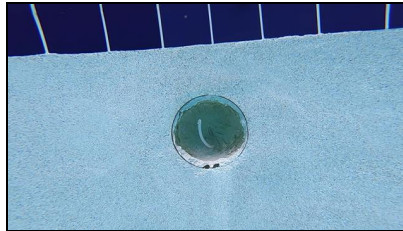
12.5 Item 1(Picture)

Pool light has been removed. The wall niche is still present. A licensed pool technician or electrician should correct as necessary.

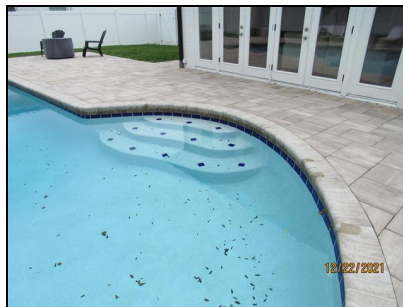
12.8 Item 1(Picture)

There is only one set of steps out of the pool. Current safety standards call for two means of exit (such as a deck mounted pool ladder or other).

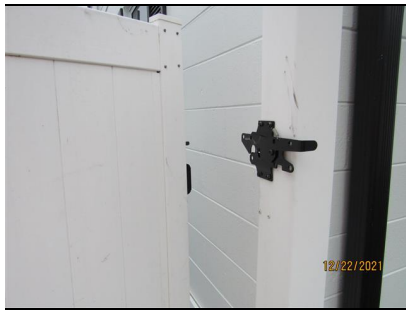
12.11 Item 1(Picture) Right gate not self latching

Gate is not self-closing / self-latching. Gates should open outward (away from the pool) and have the latch mechanism at a minimum height of 54 inches from the bottom of the gate.
